**Drip Tape Application Study
NOF and NBM**

June 8, 2010

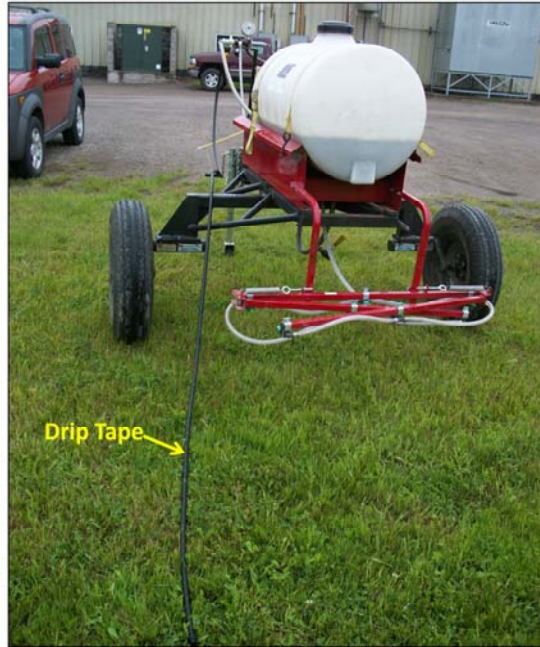
- A 5% solution of 4-3-3 and water was prepared in the AGGRAND tow behind sprayer
- 10 feet of irrigation tape and associated fittings were attached to the external spray outlet on the sprayer.
- The sprayer engine and associated pump were run several minutes to mix the 4-3-3 and water. The unit was also moved back and forth to facilitate mixing.
- The engine was set at \approx 2400 RPM with system pressure at 25 psi and run for 30 minutes

4-3-3 Test Apparatus Set-up

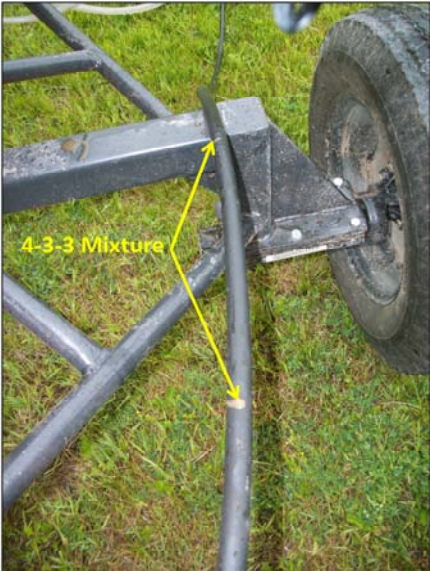
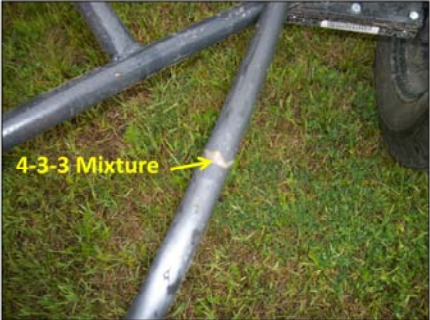
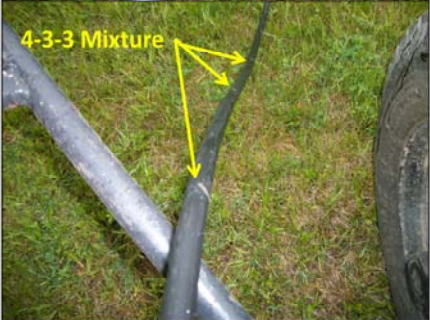
- The system was allowed to run for 30 minutes
 - With no clogged drippers
 - Flow did not seem to be reduced during the test time at any orifice
 - System pressure remained at 25 psi during the entire test
- Total volume emitted \approx 2 gallons

4-3-3 Testing: Tape Flow

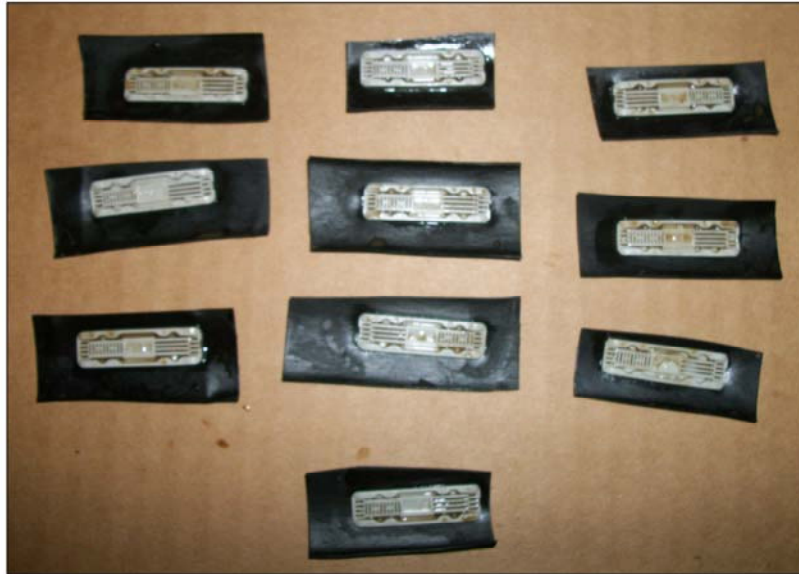
- After the testing was complete, the 10 foot section of irrigation tape was cut open and evaluated for screen blinding in the drippers (using microscope), and residual fertilizer solids remaining in the tape.
- Conclusion: No residual solids were evident in the drippers or in the tape.

4-3-3 Testing: Dripper Evaluation

The AGGRAND 4-3-3 product can be incorporated into irrigation water and delivered through drip irrigation systems with this and similar types of tapes without clogging. The 0-12-0 product did not clog the drippers, but the larger particle size bone meal accumulated in the tape, and over time would block the system.

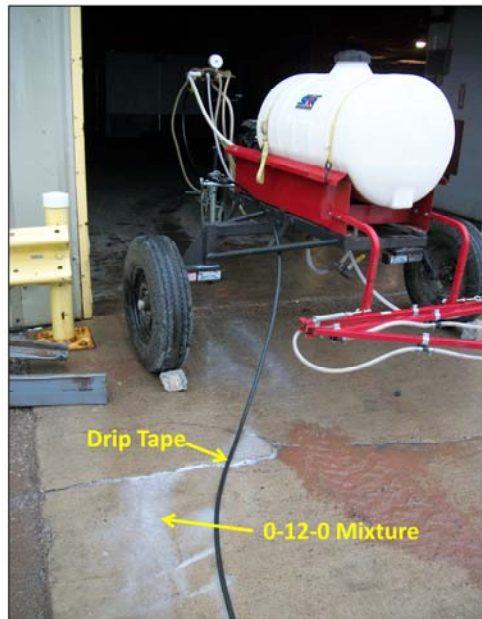
- A 5% solution of 0-12-0 and water was prepared in the AGGRAND tow behind sprayer
- 10 feet of irrigation tape and associated fittings were attached to the external spray outlet on the sprayer.
- The sprayer engine and associated pump were run several minutes to mix the 0-12-0 and water. The unit was also moved back and forth to facilitate mixing.
- The engine was set at \approx 2400 RPM with system pressure at 30 psi and run for 30 minutes

0-12-0 Test Apparatus Set-up

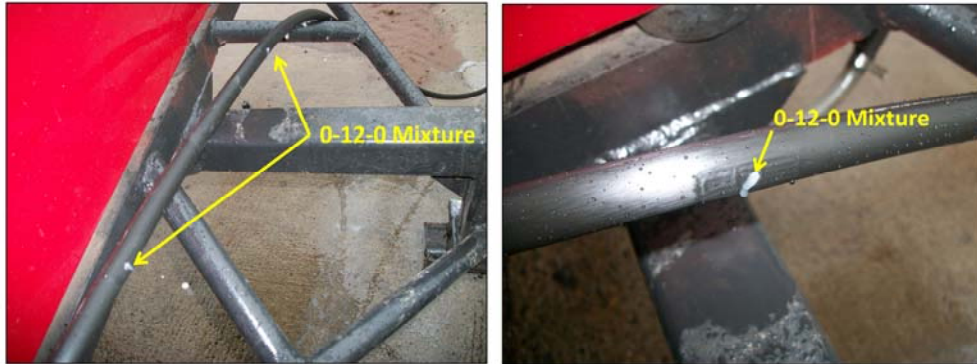
- The system was allowed to run for 30 minutes
 - With no clogged drippers
 - Flow seemed to be reduced slightly in one dripper during the test time, all others appeared to flow well
 - System pressure increased to 35 psi during the test, indicating some restriction
- Total volume emitted \approx 2 gallons

0-12-0 Testing: Tape Flow

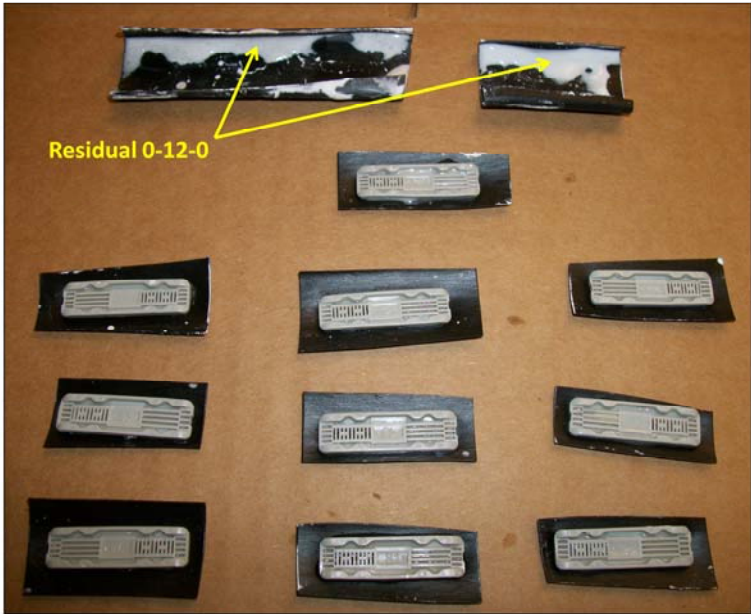
- After the testing was complete, the 10 foot section of irrigation tape was cut open and evaluated for screen blinding in the drippers (using microscope), and residual bone meal solids remaining in the tape.
- Conclusion: Residual solids were found in the tape and at the associated dripper at 3 feet from the end of the tape.

0-12-0: Dropper/Tape Evaluation

When using AGGRAND products it is recommended the pre-filter screen to the irrigation system be removed, and after fertilizer application, the system be flushed with a small amount of water to remove residual amount of fertilizer and bone meal.
